COMBAT DAMAGE ASSESSMENT TEAM
A-10/GAU-8 LOW ANGLE FIRINGS
VERSUS
SIMULATED SOVIET TANK COMPANY (ARRAY 25)
(LAVP LOT NUMBER AJD79A181-001)
(4 DECEMBER 1979)

R.H.S. STOLFI
R.R. McEACHIN

OCTOBER 1980

4. TITLE (and Subtitle) A-10/GAU-8 Low Angle Firing against Simu- lated Soviet Tank Company (Array 25) on 4 December 1979 (LAVP Lot # AJD 79A181-001 Aerojet).		5. TYPE OF REPORT & PERIOD COVERED Special report on LAVP Firings of 4 Dec. 1979

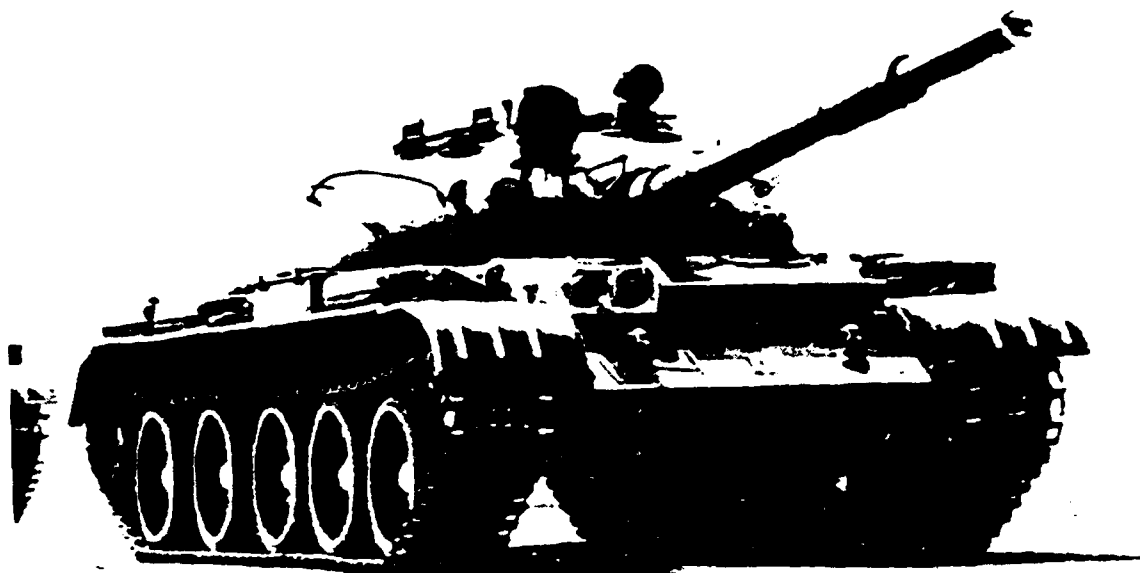
FIGURE 1. Russian T62 Medium Tank.

The most effective targets, available in sufficient numbers to simulate Soviet T-55 and T-62 tanks (Figure 1), were the US M-47 tanks. Both of the Soviet tank models are similar in armor protection to the M-47. With appropriate purging of the gasoline fuel system of the US tanks, the CDAT managed to field targets similar in survivability to the T-55 and T-62 tanks in terms of their ignitable internal material. Few data are available on armor protection and the arrangement of internal components in the Soviet T-64 and later model tanks. The decision was made, accordingly, to simulate the earlier model Soviet tanks with the readily available US tank equivalents.

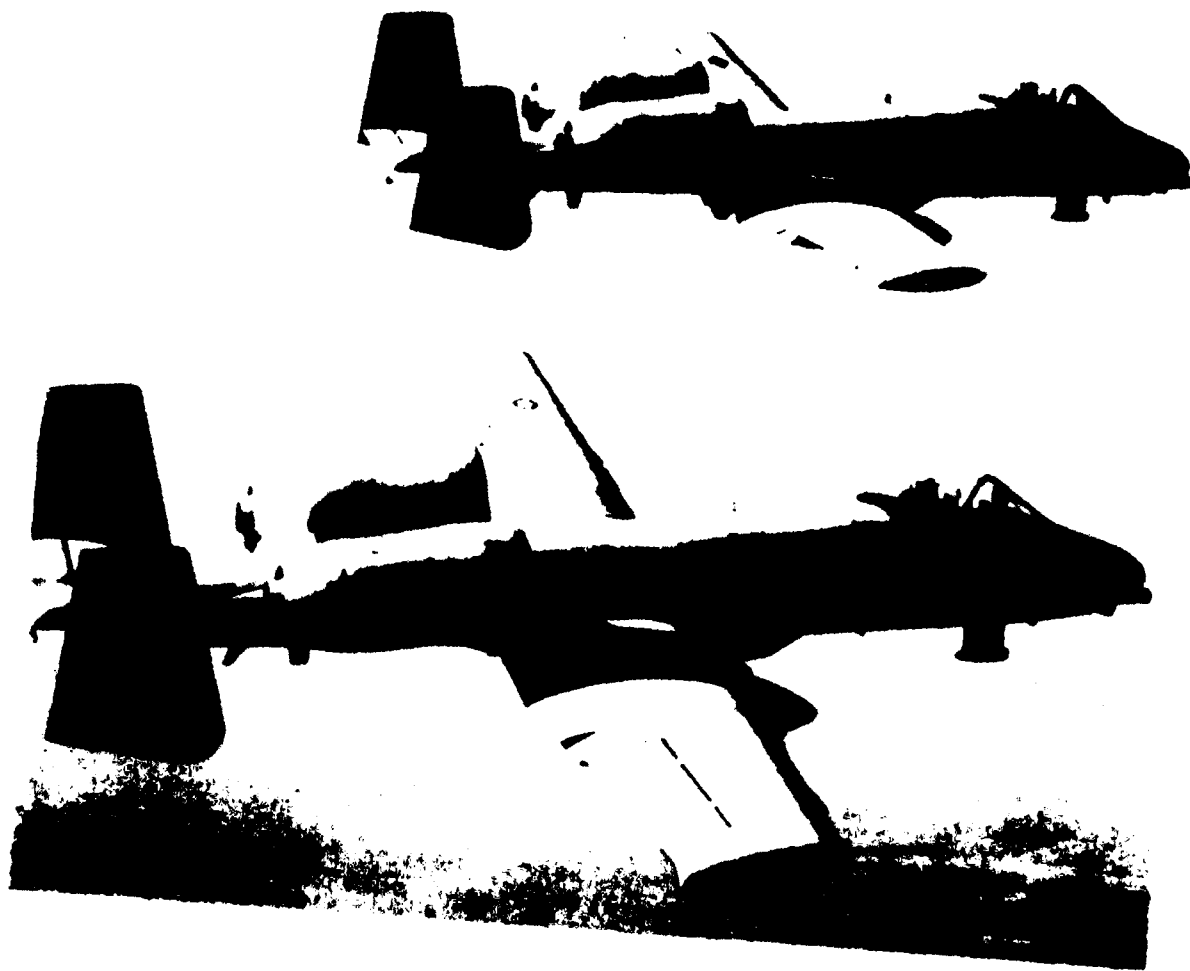
FIGURE 2. USAF/Fairchild Republic A-10 Close Ground Support Aircraft.
